## Temperature and Vibration Testing on Zafety Lug Lock

A Report to: TAFKAN Consulting Ltd.  
2107 Pinevalley Crescent  
Oakville, ON  
L6H 6L8

Report No.: 09-03-C0193 Revision 1  
3 Pages, 2 Appendices

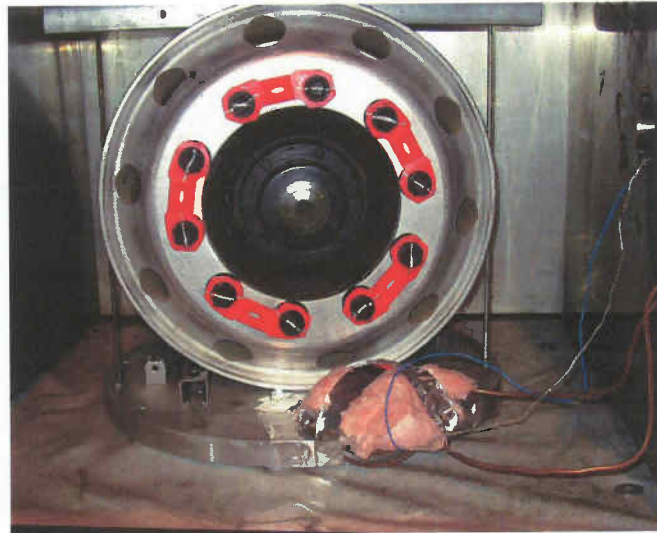
Figure 1A  
Vibration test set-up inside the *THERMOTRON* chamber (26 in. Hub Pilot Alloy Rim)

The vibration at temperature tests were performed on a vertical motion *THERMOTRON DS-640* shaker table situated inside a *THERMOTRON* thermal chamber. The wheel was attached to the vibration platform with its vertical axis parallel to the vibration platform's thrust direction. Hence, the sample was vibrated in the vertical direction (Z axis), as shown in Appendix A, Figure 1A. One accelerometer which provided the control signal was attached to the vibration platform in thrust direction.

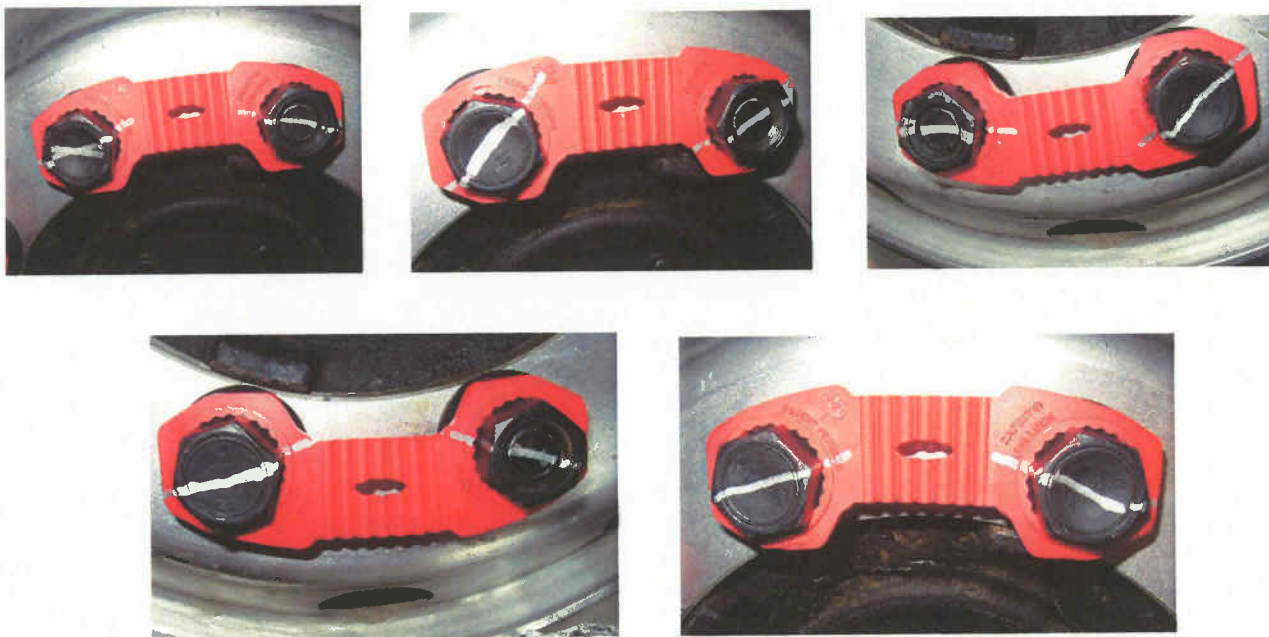
Figure 2A  
The various lug nuts and Zafety Lug Lock units, indicating the position of the lug nuts prior to testing

(Note: the photographs above indicate that the respective nuts did not move; however, some of the cap washers rotated due to vibration and high temperature.)

1. 26" Hub Pilot Alloy Rim, prior to vibration testing: Figure 1A and Figure 2A,
2. 26" Hub Pilot Alloy Rim, after vibration testing at 150°C: Figure 3A and Figure 4A,
3. 26" Hub Pilot Alloy Rim, after vibration testing at -40°C: Figure 5A and Figure 6A.

Based on the photographic documentation there was no evidence that any of the nuts had moved. However, some of the cap washers (located inside the nut) had moved due the effect of high temperature and vibration. A cap washer is shown in Appendix A, Figure 7A and Figure 8A.

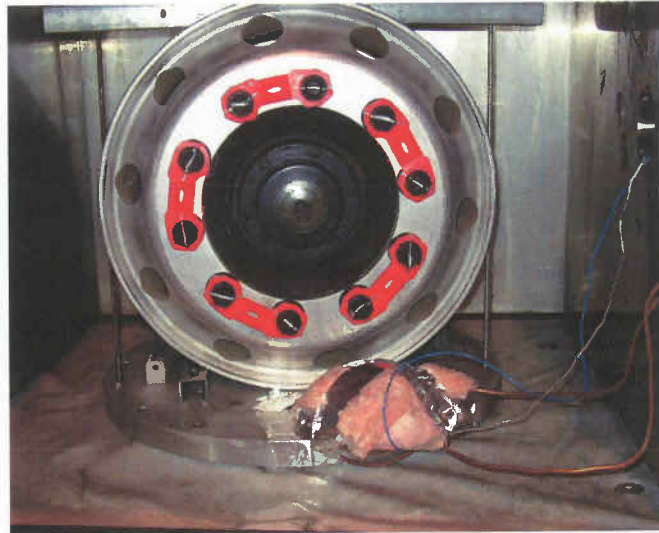
Figure 3A  
Vibration test set-up inside the *THERMOTRON* chamber (26 in. Hub Pilot Alloy Rim)

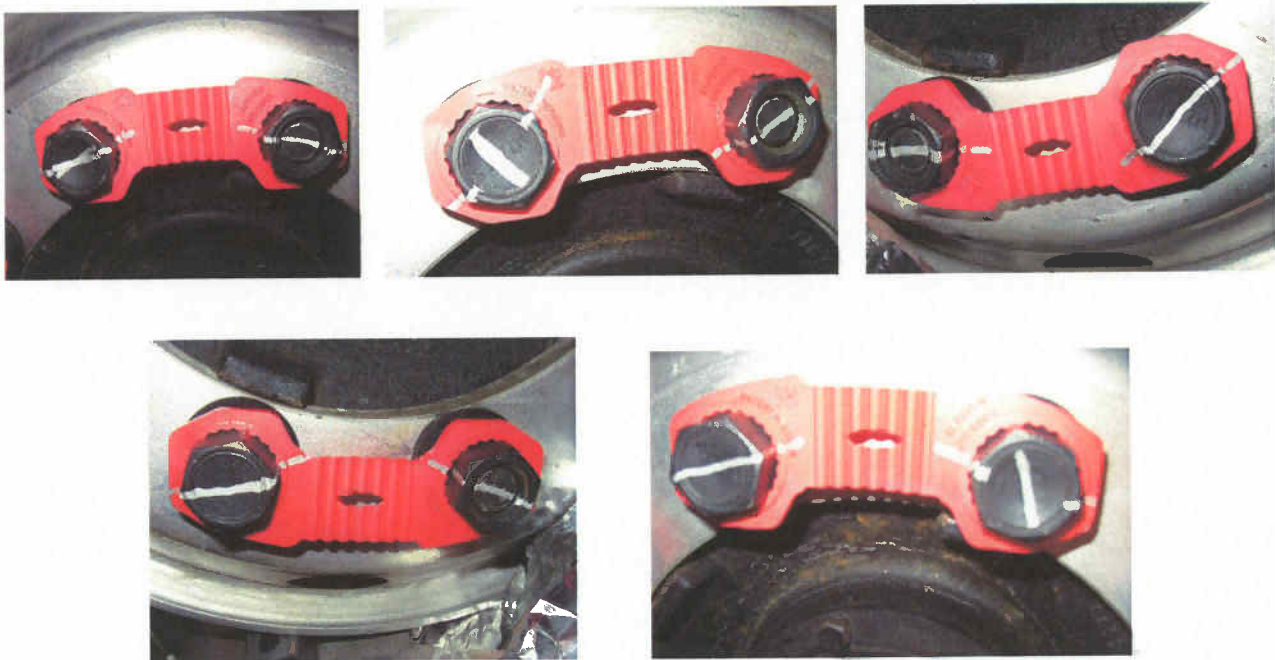
Figure 4A  
The various lug nuts and Safety Lug Lock units, indicating the position of the lug nuts after testing at 150°C

(Note: the photographs above indicate that the respective nuts did not move; however, some of the cap washers rotated due to vibration and high temperature.)

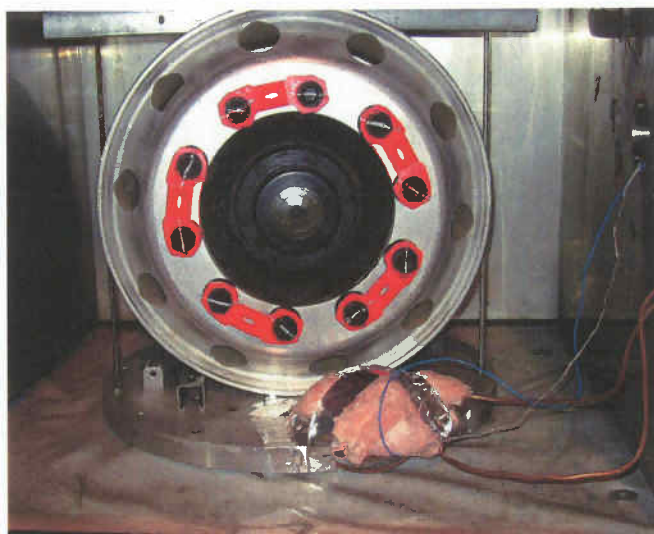
Figure 5A  
Vibration test set-up inside the *THERMOTRON* chamber (26 in. Hub Pilot Alloy Rim)

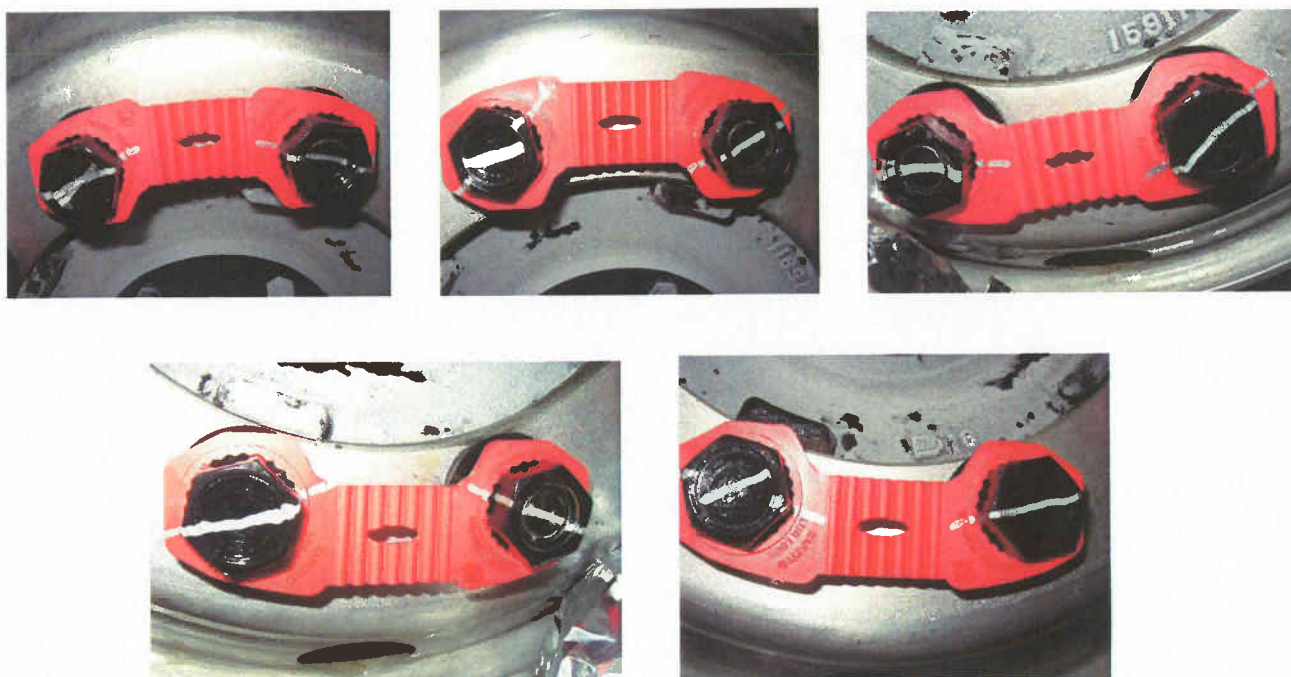
Figure 6A

The various lug nuts and Zafety Lug Lock units, indicating the position of the lug nuts after testing at  $-40^{\circ}\text{C}$

(Note: the photographs above indicate that the respective nuts did not move; however, some of the cap washers rotated due to vibration and high temperature.)

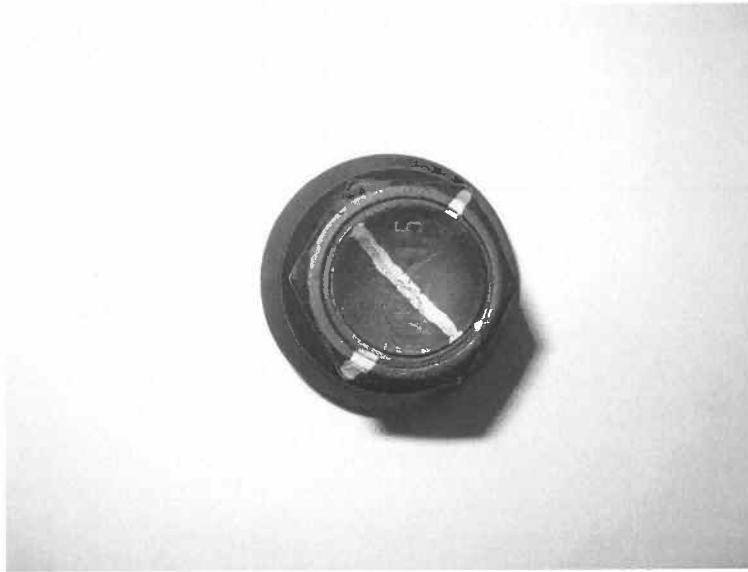
Figure 7A  
Wheel nut with installed cap washer

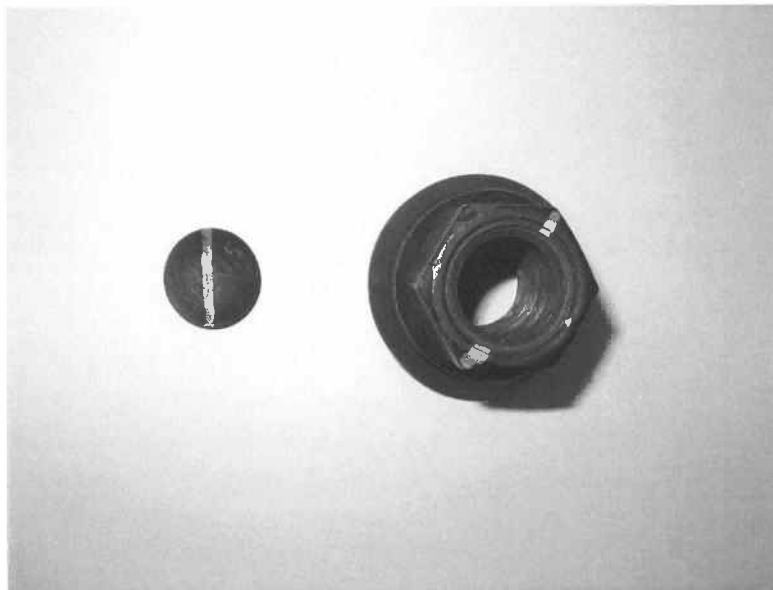
Figure 8A  
Wheel nut and cap washer

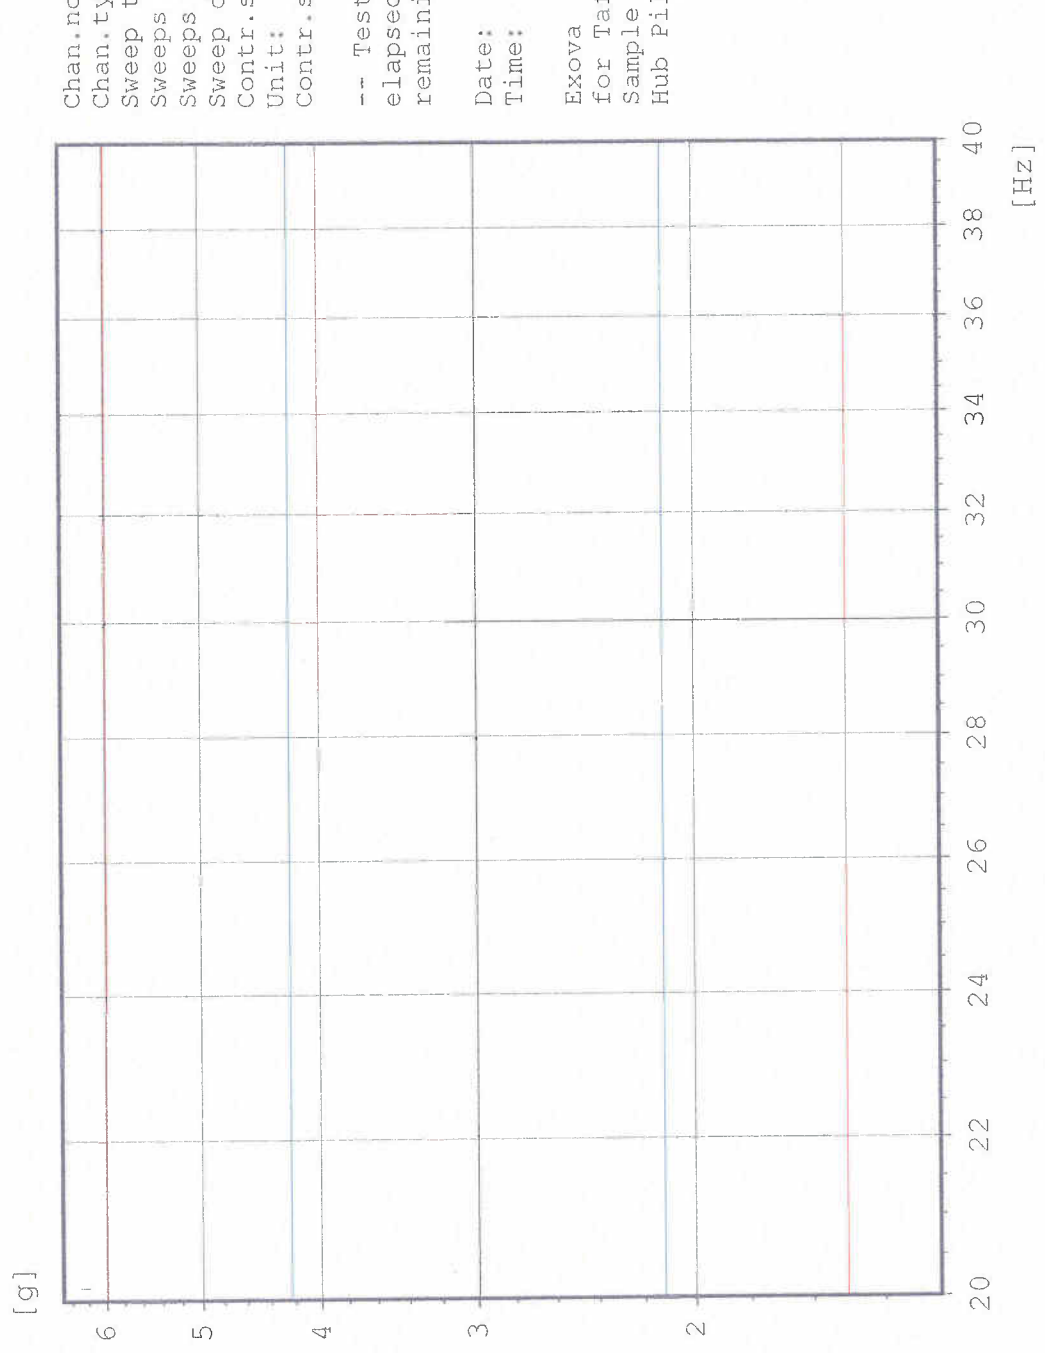
Figure 1B *[Signature]*

Sine Dwell  
Vertical Direction  
1 Hr. 30 Hz & 3 g dwell at 150C

Chan.no: 1  
Chan.type: CW  
Sweep type: logarithmic  
Sweeps done: 1  
Sweeps req.: 1  
Sweep direct.:  
Contr.strat.: Average  
Unit: g  
Contr.strat.: Closed loop

-- Testing time --  
elapsed: 001:00:00  
remaining: 000:00:00

Vibration controller generated plots for the vibration tests are provided in Appendix B, Figures 1B and 2B.

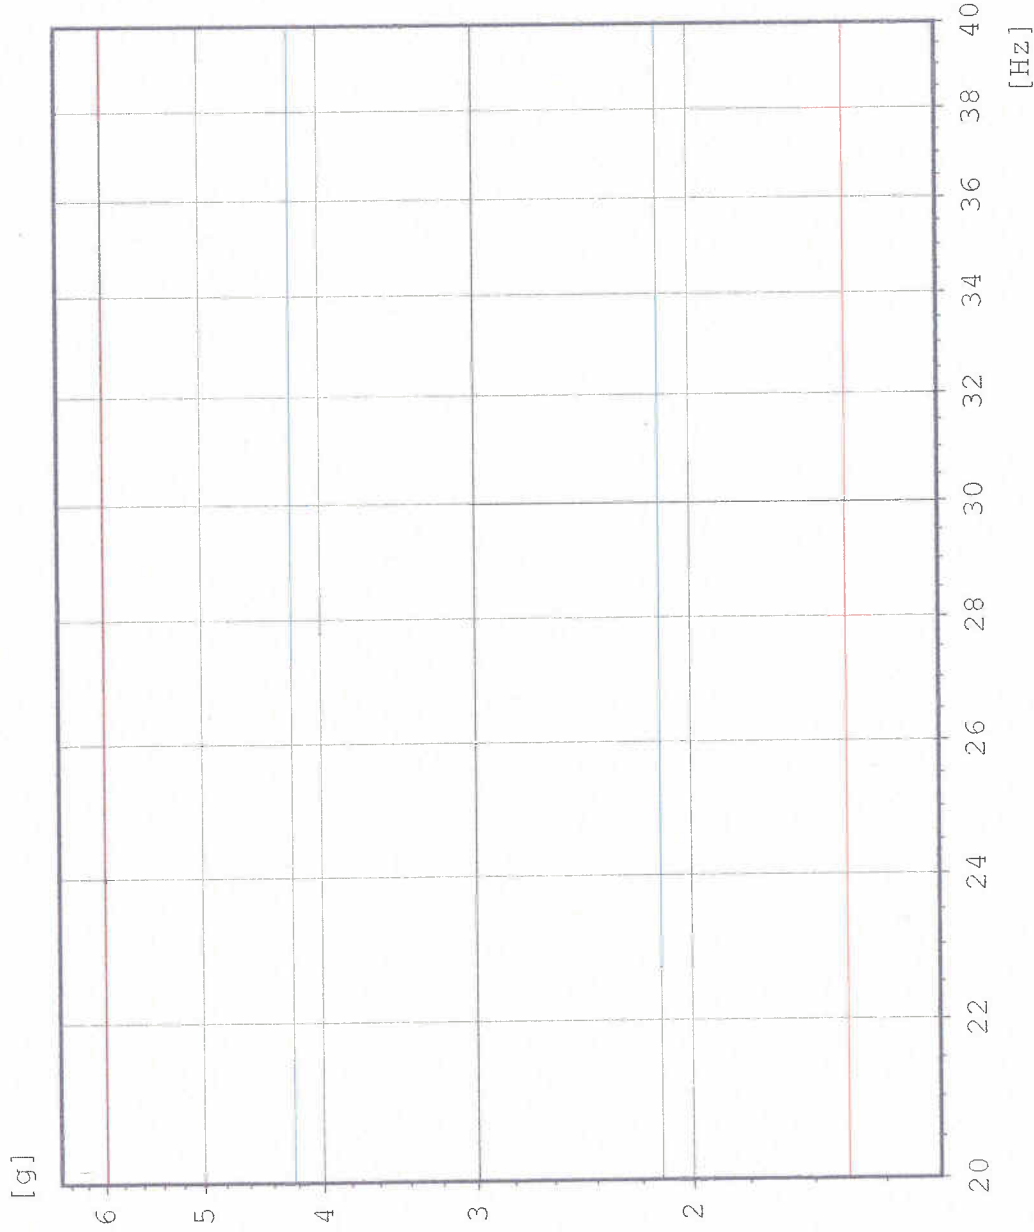
Figure 2B

Sine Dwell

Vertical Direction

1 Hr. 30 Hz & 3 g dwell at 150C

Chan.no: 1  
Chan.type: CW  
Sweep type: logarithmic  
Sweeps done: 1  
Sweeps req.: 1  
Sweep direct.:  
Contr.strat.: Average  
Unit: g  
Contr.strat.: Closed loop

-- Testing time --  
elapsed: 001:00:00  
remaining: 000:00:00
