# HUB ALERT™

REPORT NUMBER 11-15-C0165B Revision 1

### **“Temperature Activation Test on HUB ALERT™ Heat Sensing Labels”**

## Temperature Activation Test on HUB ALERT™ Heat Sensing Labels

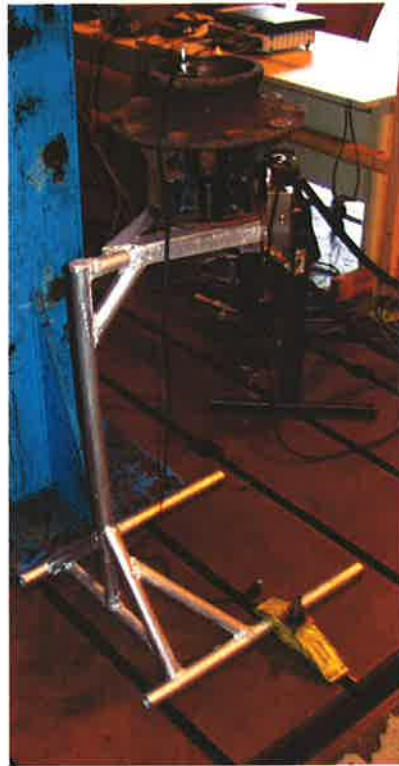
Figure 1A : The steel hub / hub cap affixed to the test fixture provided

- One aluminum hub cap (STEMCO HUB-SEAL 2, Longview, Texas, 4009).
- One plastic hub cap (International 3531209C91, U.S. Pat. 5,505, 525).
- One steel hub and hub cap (6-X-1350 FOM B110-9).
- Metal fixture for mounting the steel hub and hub cap horizontally and a 1500 W, 120 V heating element (FITSALL™) heating element to fit into the oil-filled hub cap (see Appendix A, Figure 1A and Figure 2A).
- Fixture for mounting the plastic and aluminum hub cap horizontally and a 120 V heating element to fit into the oil-filled hub cap (see Appendix A, Figure 3A and Figure 4A).
- Four 1 quart bottles of Delo® SAE 80W-90 gear lubricant ESI.

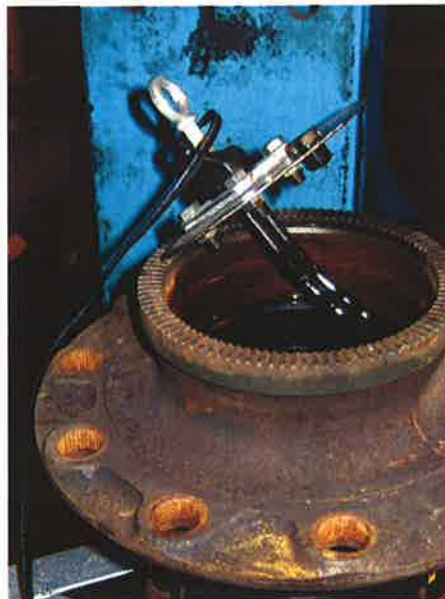
Figure 2A : The heating element for insertion into the oil-filled hub

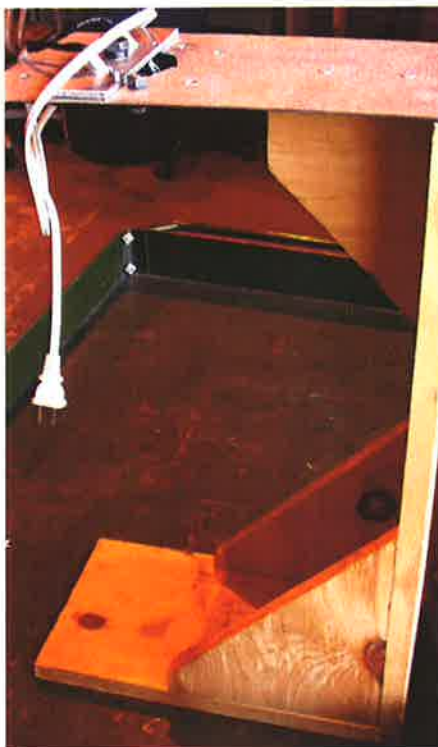
Figure 3A : The plastic hub cap affixed to the test fixture provided

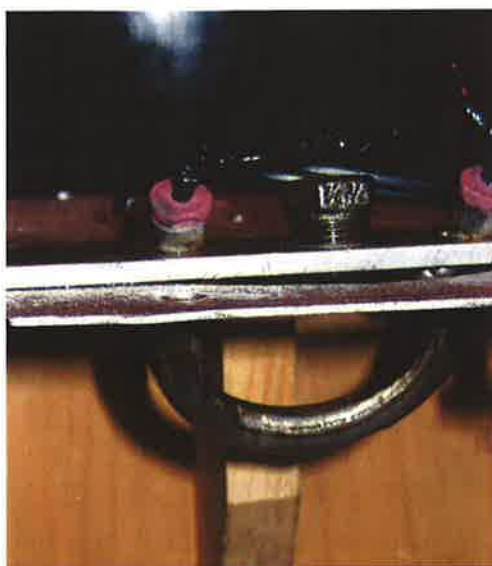
Figure 4A : The heating element for insertion into the oil-filled hub cap (plastic and aluminum hub caps)

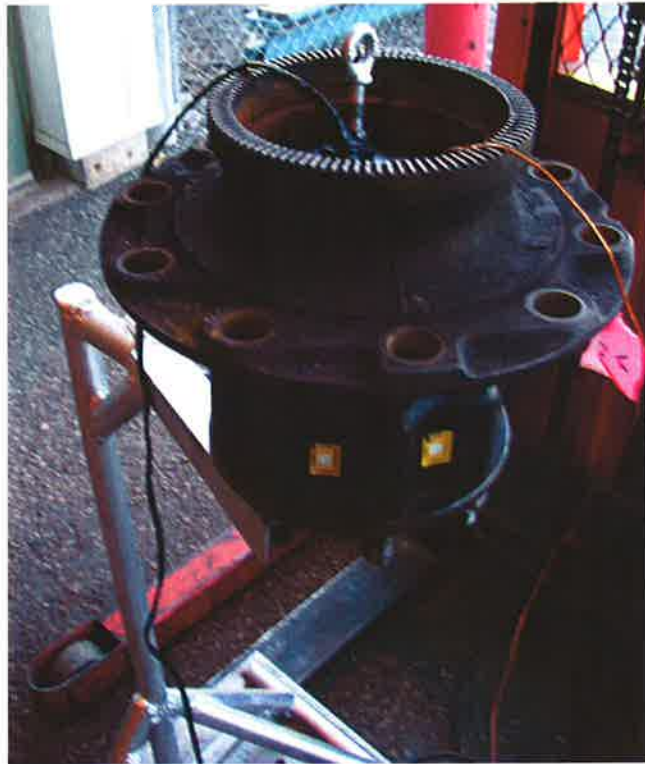
Figure 5A : Temperature activation test set-up for the steel hub and hub cap

A photograph of the test set-up is provided in Appendix A, Figure 5A.

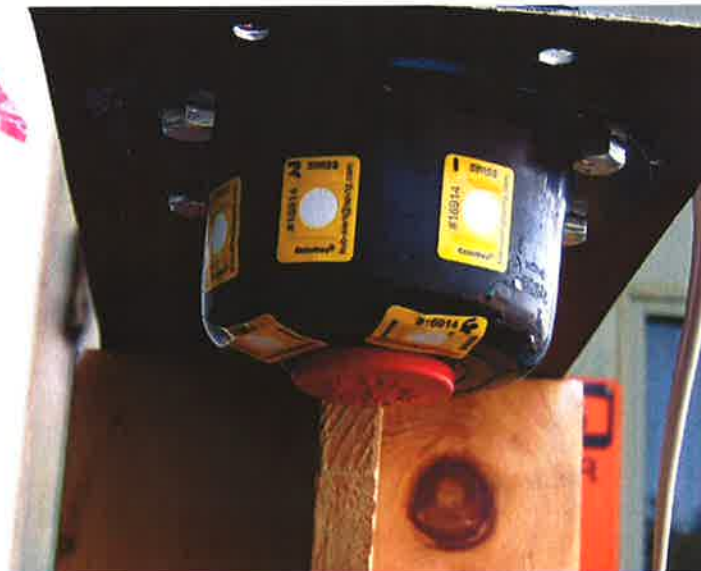
Figure 6A : Temperature activation test set-up for the plastic hub cap

A photograph of the test set-up for the plastic hub cap is provided in Appendix A, Figure 6A while a photograph of the test set-up for the aluminum hub cap is provided in Appendix A, Figure 7A.

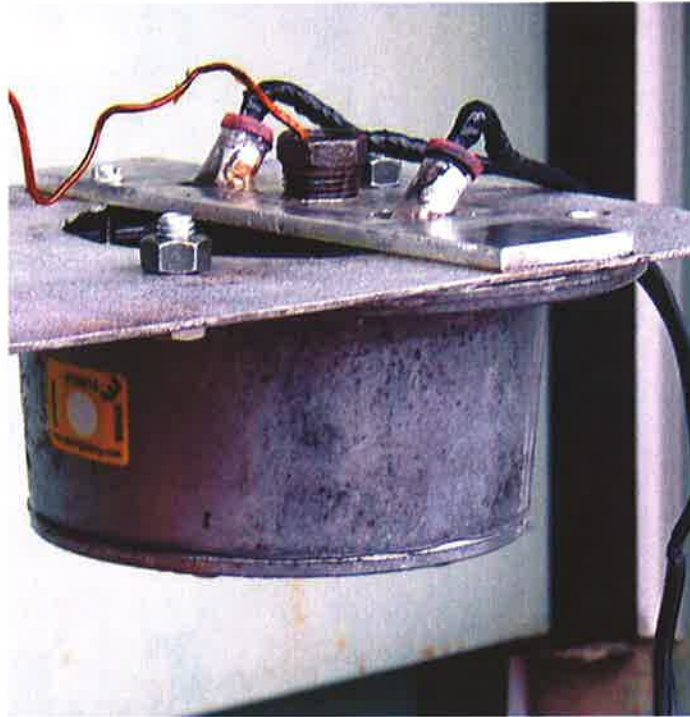
Figure 7A : Temperature activation test set-up for the aluminum hub cap

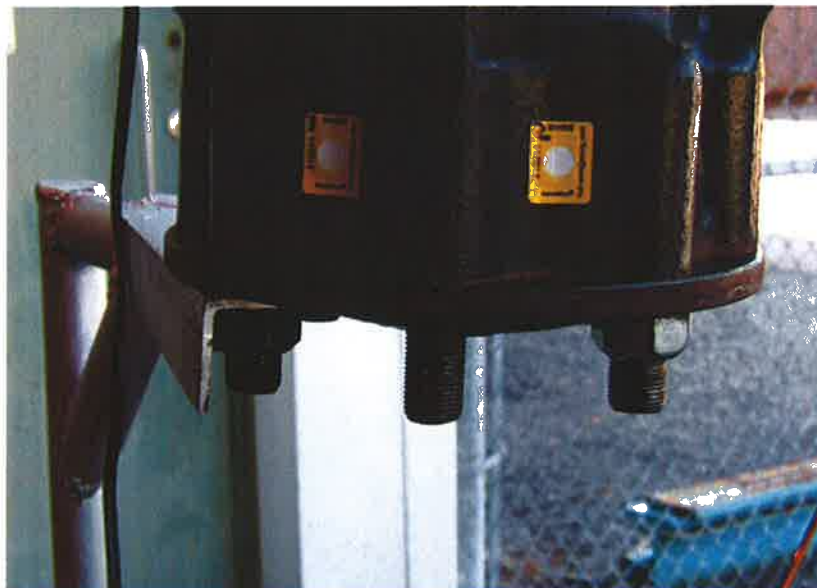
Figure 8A : Labels attached to the side of the steel hub

Five HUB ALERT™ heat sensing labels were attached, three to the side of the hub surface and two to the surface of the hub cap (see Appendix A, Figure 8A and 9A, respectively).

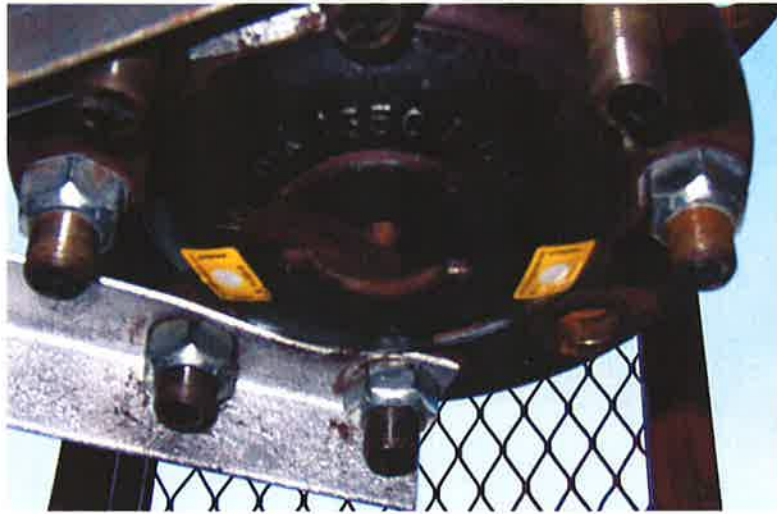
Figure 9A : Labels attached to the surface of the steel hub hub cap

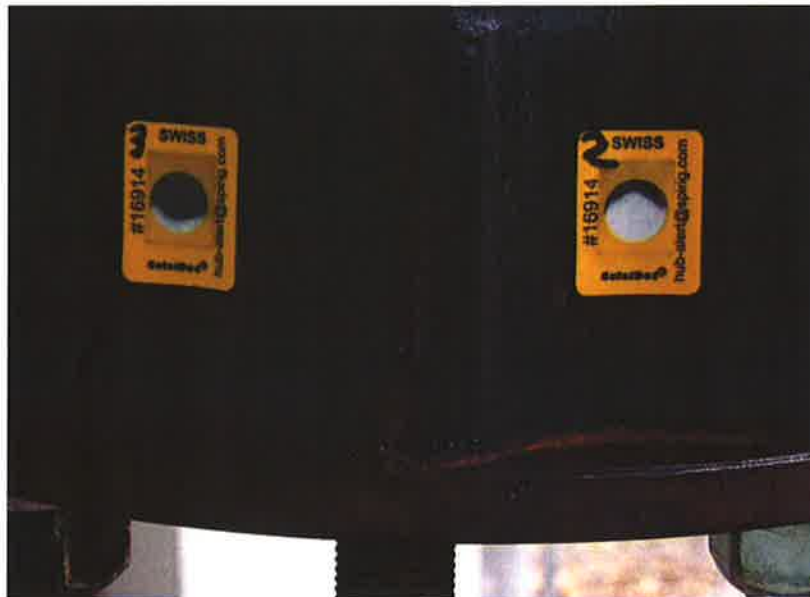
Figure 10A : Steel hub with labels – Partial temperature activation of HUB ALERT™ heat sensing labels  
(Exova sample numbers 11-15-0165-29 and 30, labels applied to side of hub)

Partial temperature activation of the HUB ALERT™ labels affixed to the side of the hub (Exova sample numbers 11-15-0165-29 and 30) is shown in Appendix A, Figure 10A and full temperature activation of the same labels is shown in Appendix A, Figure 11A. Partial temperature activation of the HUB ALERT™ labels affixed to the surface of the hub cap (Exova sample numbers 11-15-0165-31 and 32) is shown in Appendix A, Figure 12A. The oil temperature data for the test is presented graphically in Appendix B, Figure 1B.

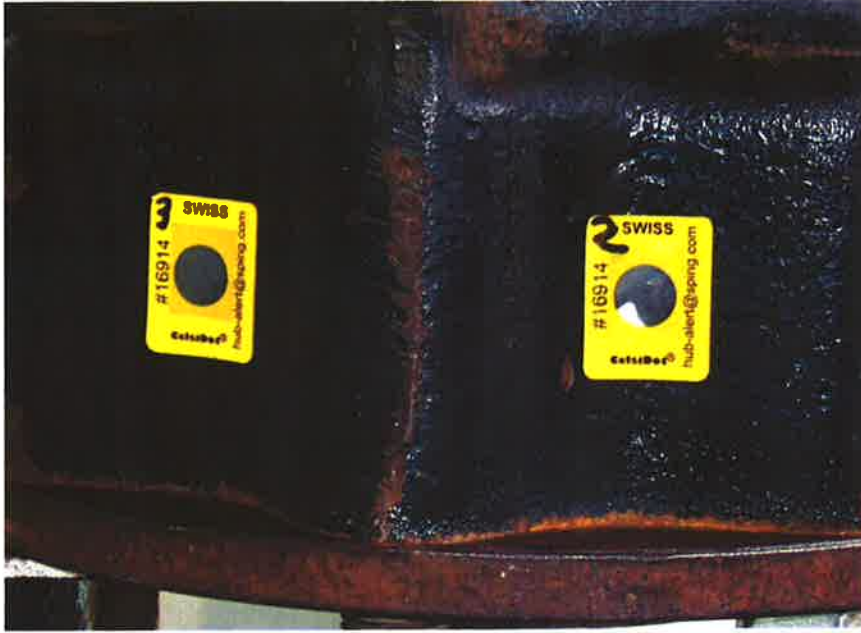
Figure 11A : Steel hub with labels – Full temperature activation of HUB ALERT™ heat sensing labels (Exova sample numbers 11-15-0165-29 and 30), labels applied to side of hub

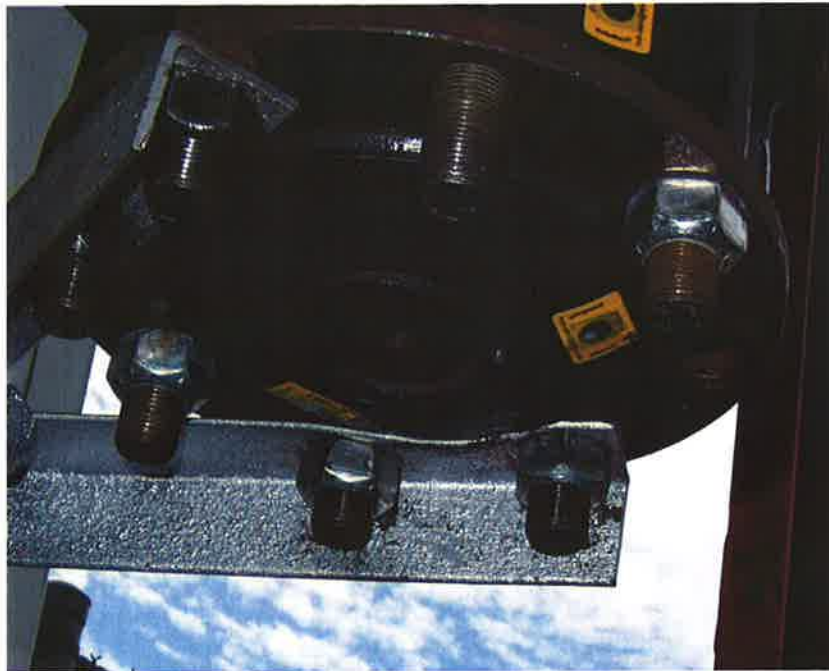
Figure 12A : Steel hub with labels – Partial temperature activation of HUB ALERT™ heat sensing labels (Exova sample numbers 11-15-0165-31 and 32), labels applied to the surface of the hub cap

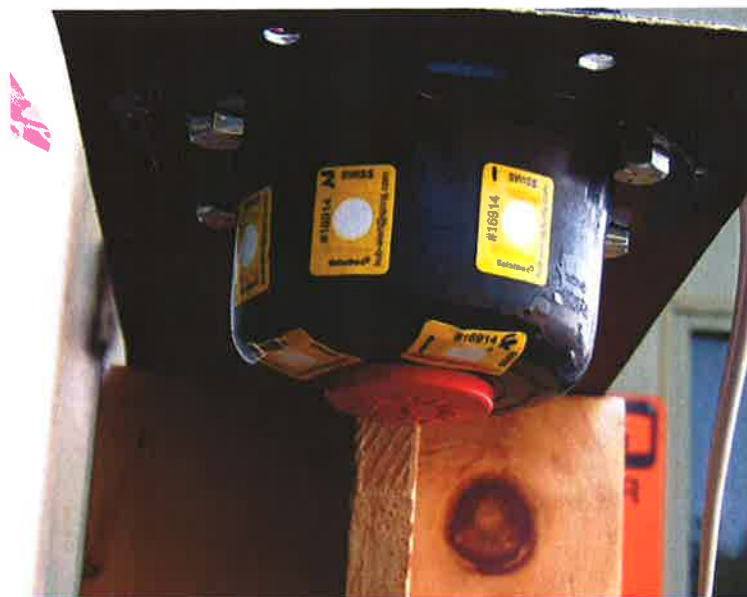
Figure 13A : Temperature activation test set-up for plastic hub cap

Three HUB ALERT™ heat sensing labels were affixed to the side surface of the hub cap and two to the end surface of the hub cap (see Appendix A, Figure 13A). As instructed by the client, the labels were attached to an area of the side that was not in proximity to the internal heating element.

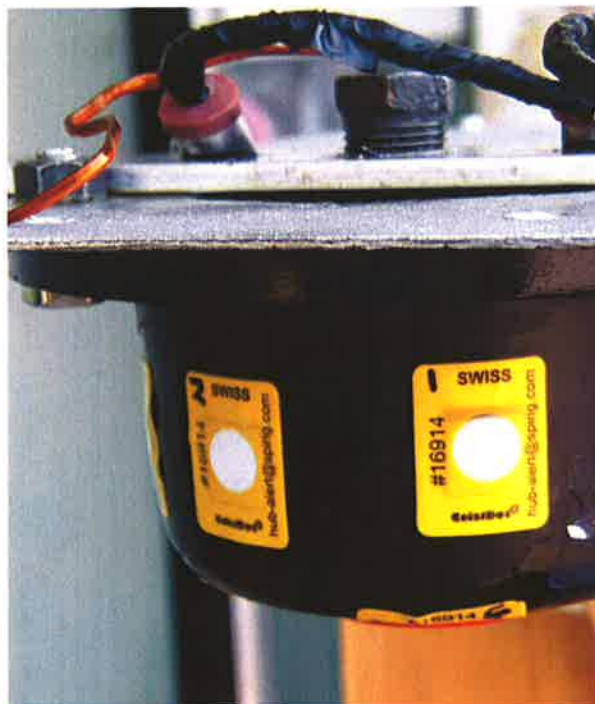
Figure 14A : Plastic hub cap, showing partial temperature activation of HUB ALERT™ heat sensing label  
(Exova sample numbers 11-15-0165-33, labels applied to side of hub cap)

Due to the hub cap's temperature gradient, only the upper halves of the labels applied to the side of the hub cap activated. The label identified with Exova sample no. 11-15-0165-33 activated first (see Appendix A, Figure 14A), followed by the other two labels applied to the side of the hub cap (see Appendix A, Figure 15A and Figure 16A). Since only the upper half of each label had activated, temperature readings were taken in these areas, as follows:

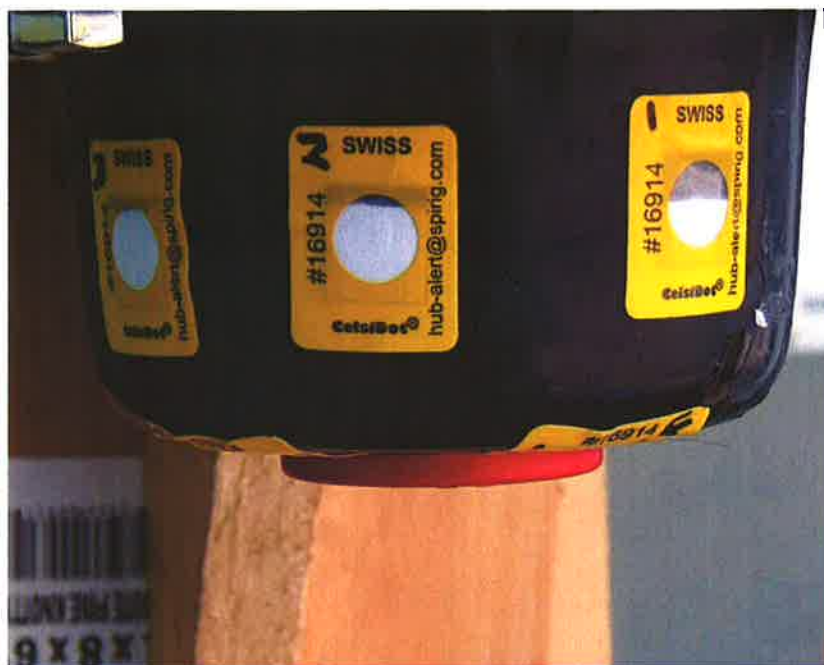
Figure 15A : Plastic hub cap, showing partial temperature activation of HUB ALERT™ heat sensing labels (Exova sample numbers 11-15-0165-33 to 35 labels applied to side of hub cap)

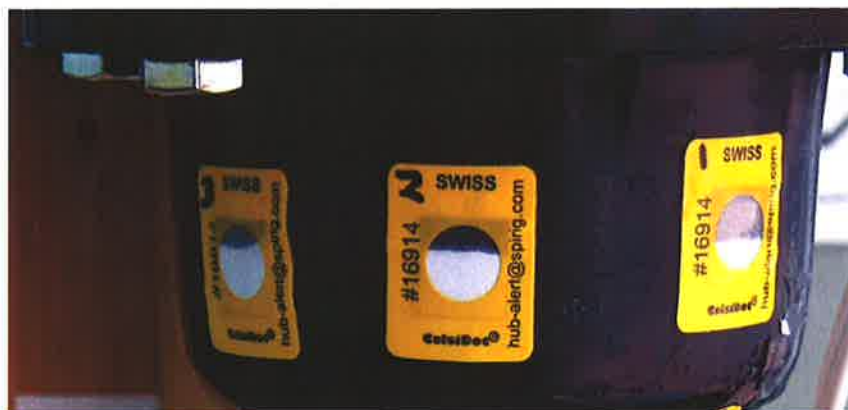
Figure 16A : Plastic hub cap, showing partial temperature activation of HUB ALERT™ heat sensing labels (Exova sample numbers 11-15-0165-33 to 35 labels applied to side of hub cap)

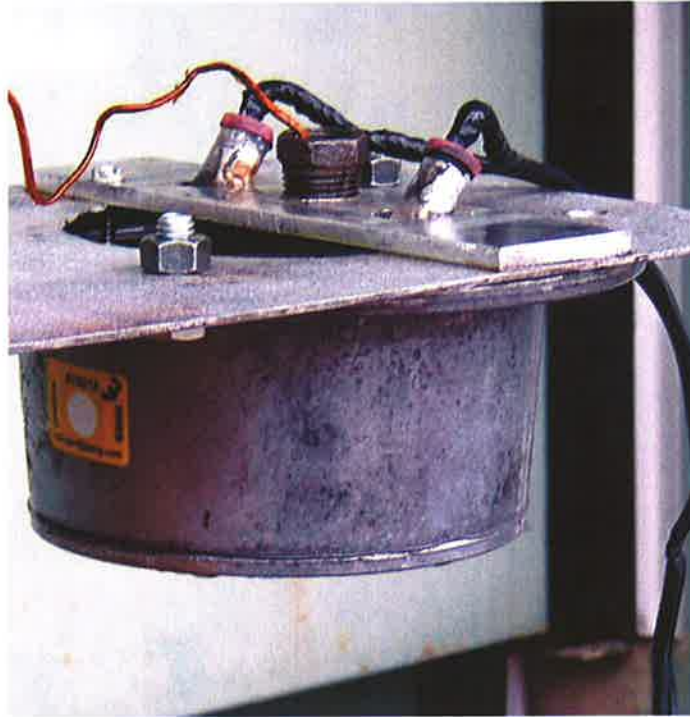
Figure 17A : Temperature activation test set-up for plastic hub cap

Three HUB ALERT™ heat sensing labels were attached to the side surface of the hub cap (see Appendix A, Figure 17A and Figure 18A). As instructed by the client, the labels were attached to an area of the side that was not in proximity to the internal heating element.

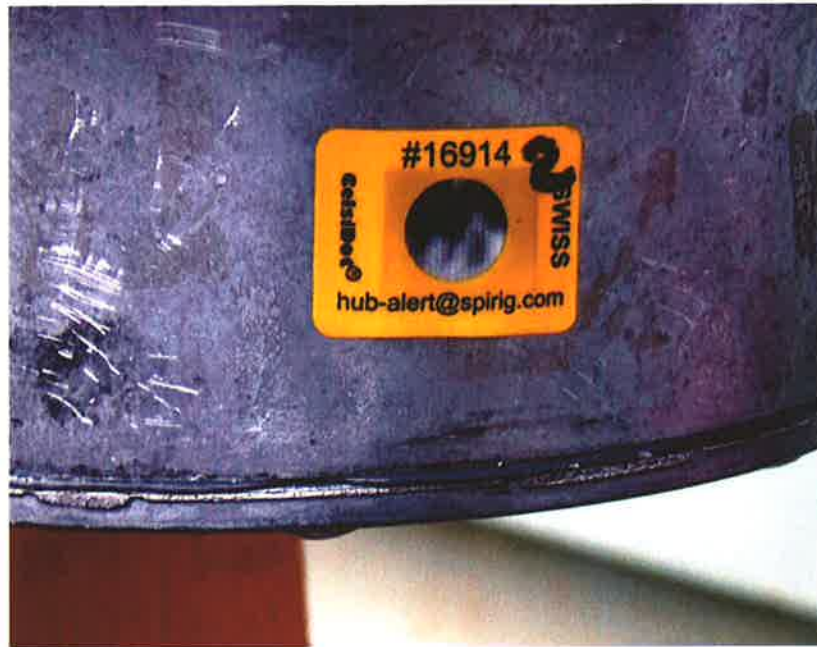
Figure 19A : Aluminum hub cap, showing partial temperature activation of HUB ALERT™ heat sensing label (Exova sample numbers 11-15-0165-39)

Partial and complete temperature activation of the HUB ALERT™ label identified with Exova sample numbers 11-15-0165-39 is shown in Appendix A, Figure 19A and Figure 20A, respectfully. Complete temperature activation of the label identified with Exova sample numbers 11-15-0165-40 is shown in Appendix A, Figure 21A.

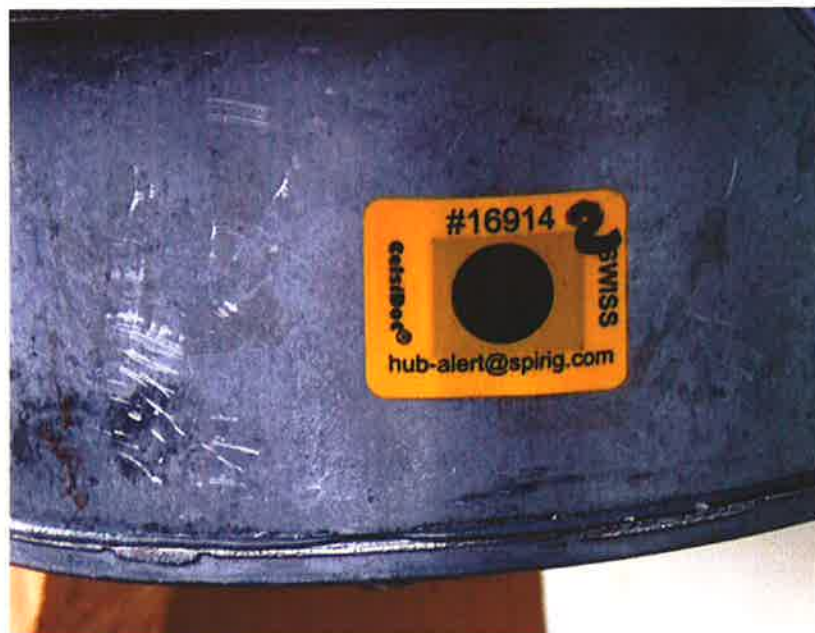
Figure 20A : Aluminum hub cap, showing complete temperature activation of HUB ALERT™ heat sensing label (Exova sample numbers 11-15-0165-39)

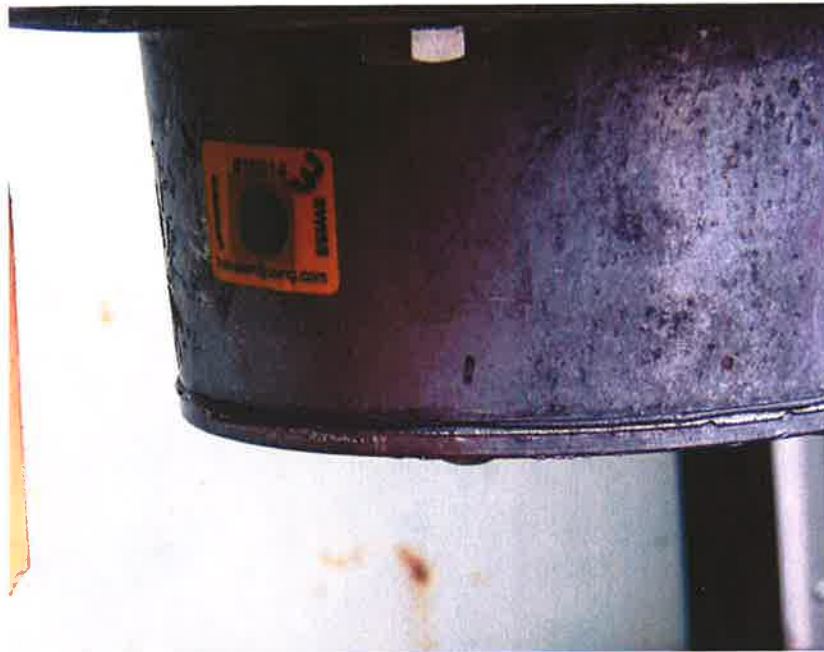
Figure 21A : Aluminum hub cap, showing complete temperature activation of HUB ALERT™ heat sensing label (Exova sample numbers 11-15-0165-40)

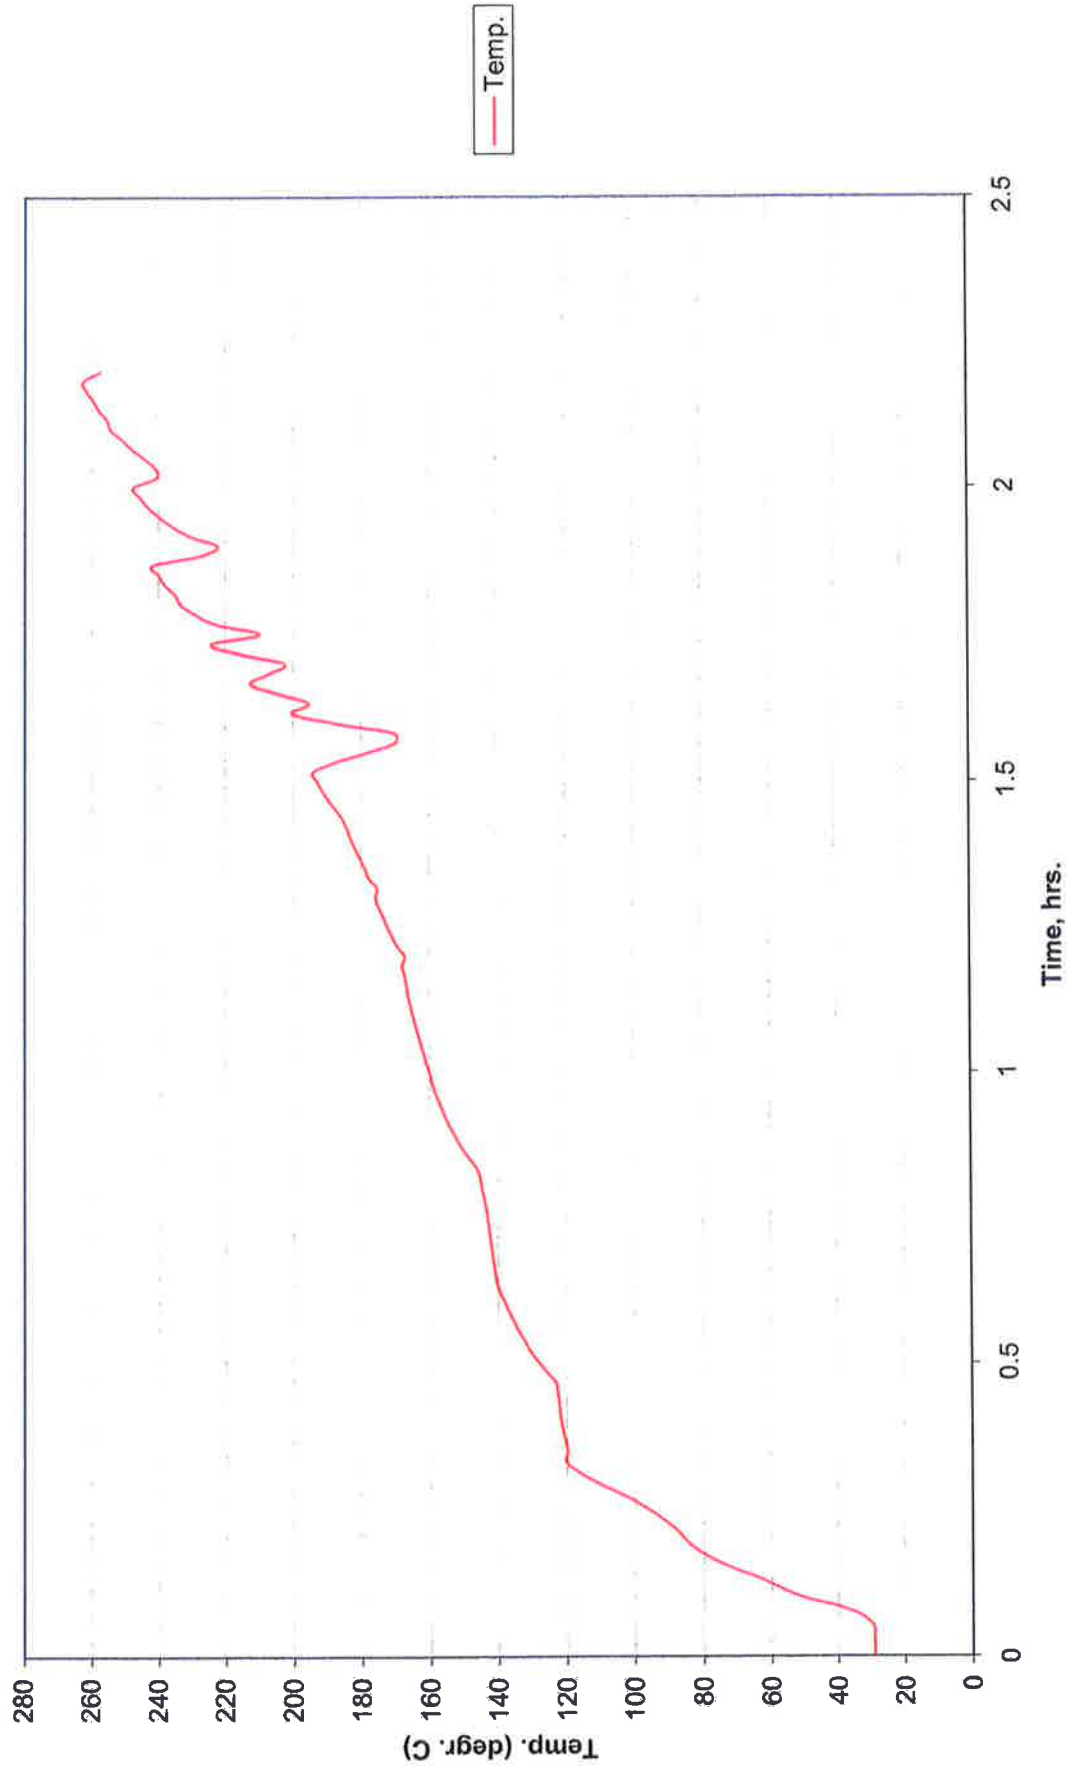
FIGURE 1B

### Temperature Activation Test: Oil Temperature for the Steel Hub and Hub Cap

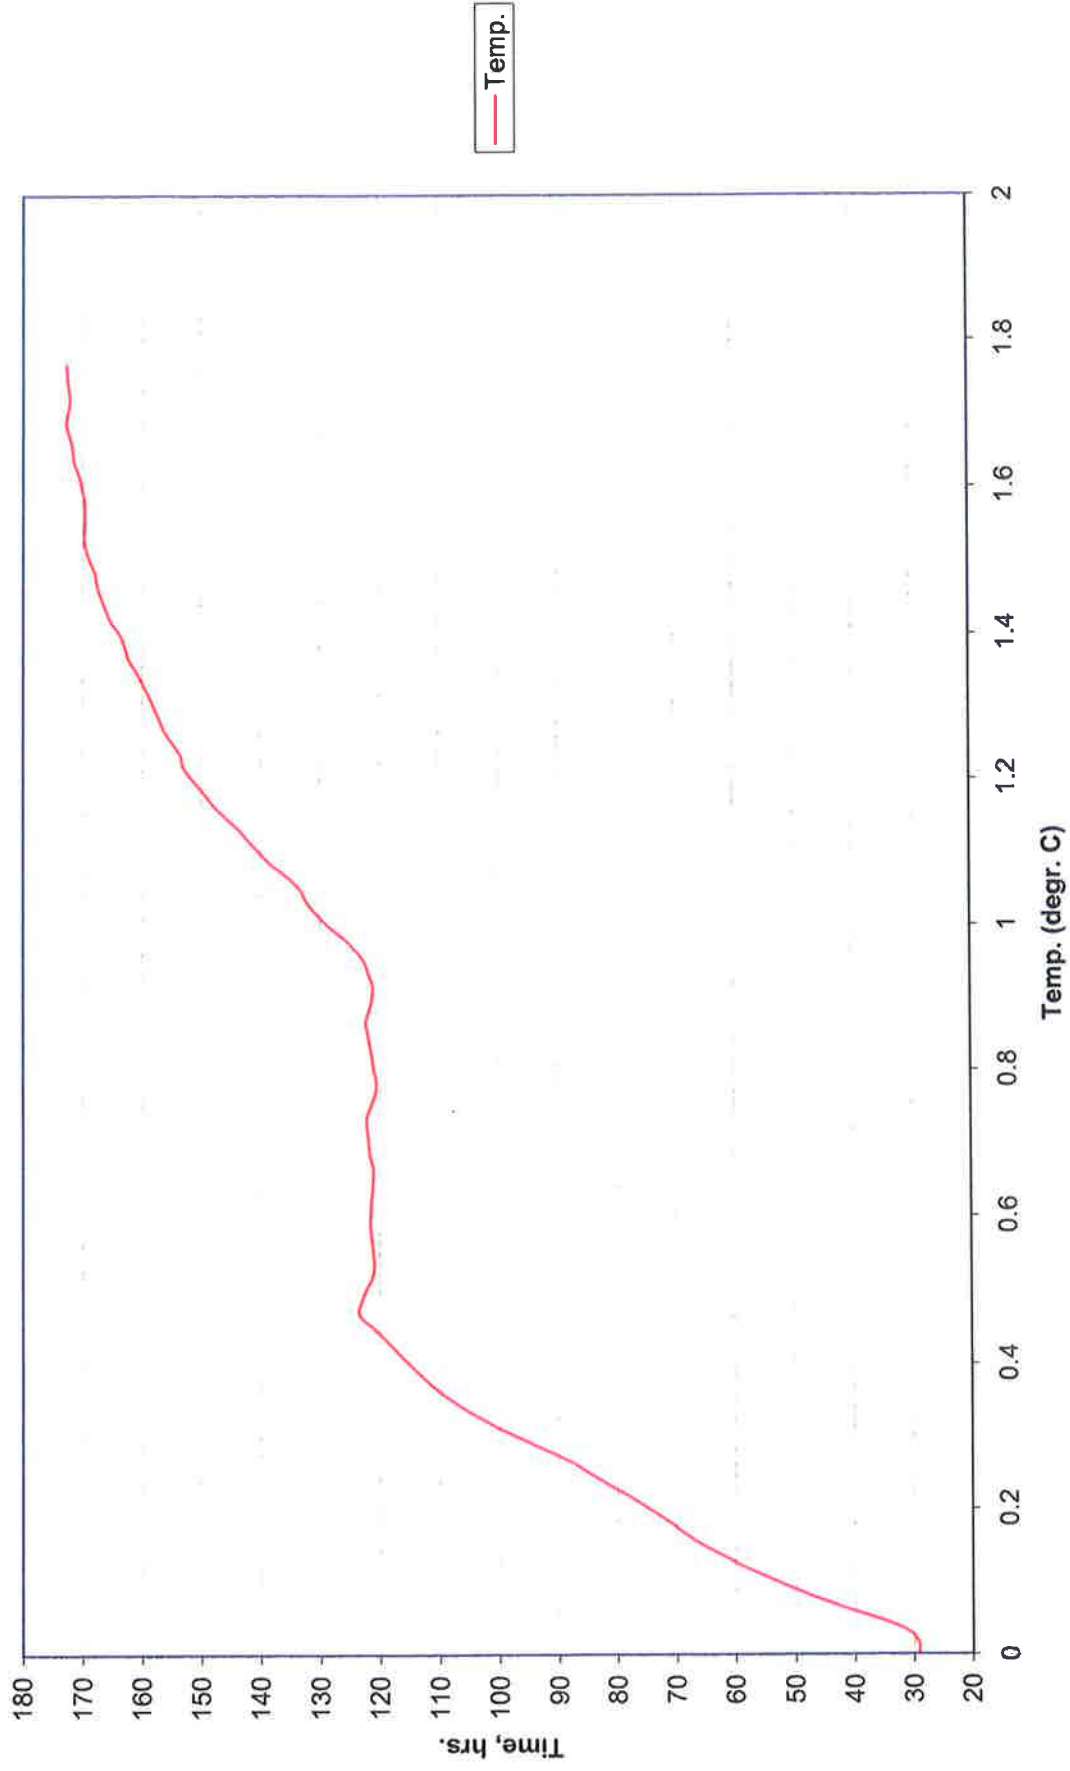
FIGURE 2B

### Temperature Activation Test: Oil Temperature for the Plastic Hub Cap

The oil temperature data for the test is presented graphically in Appendix B, Figure 2B.

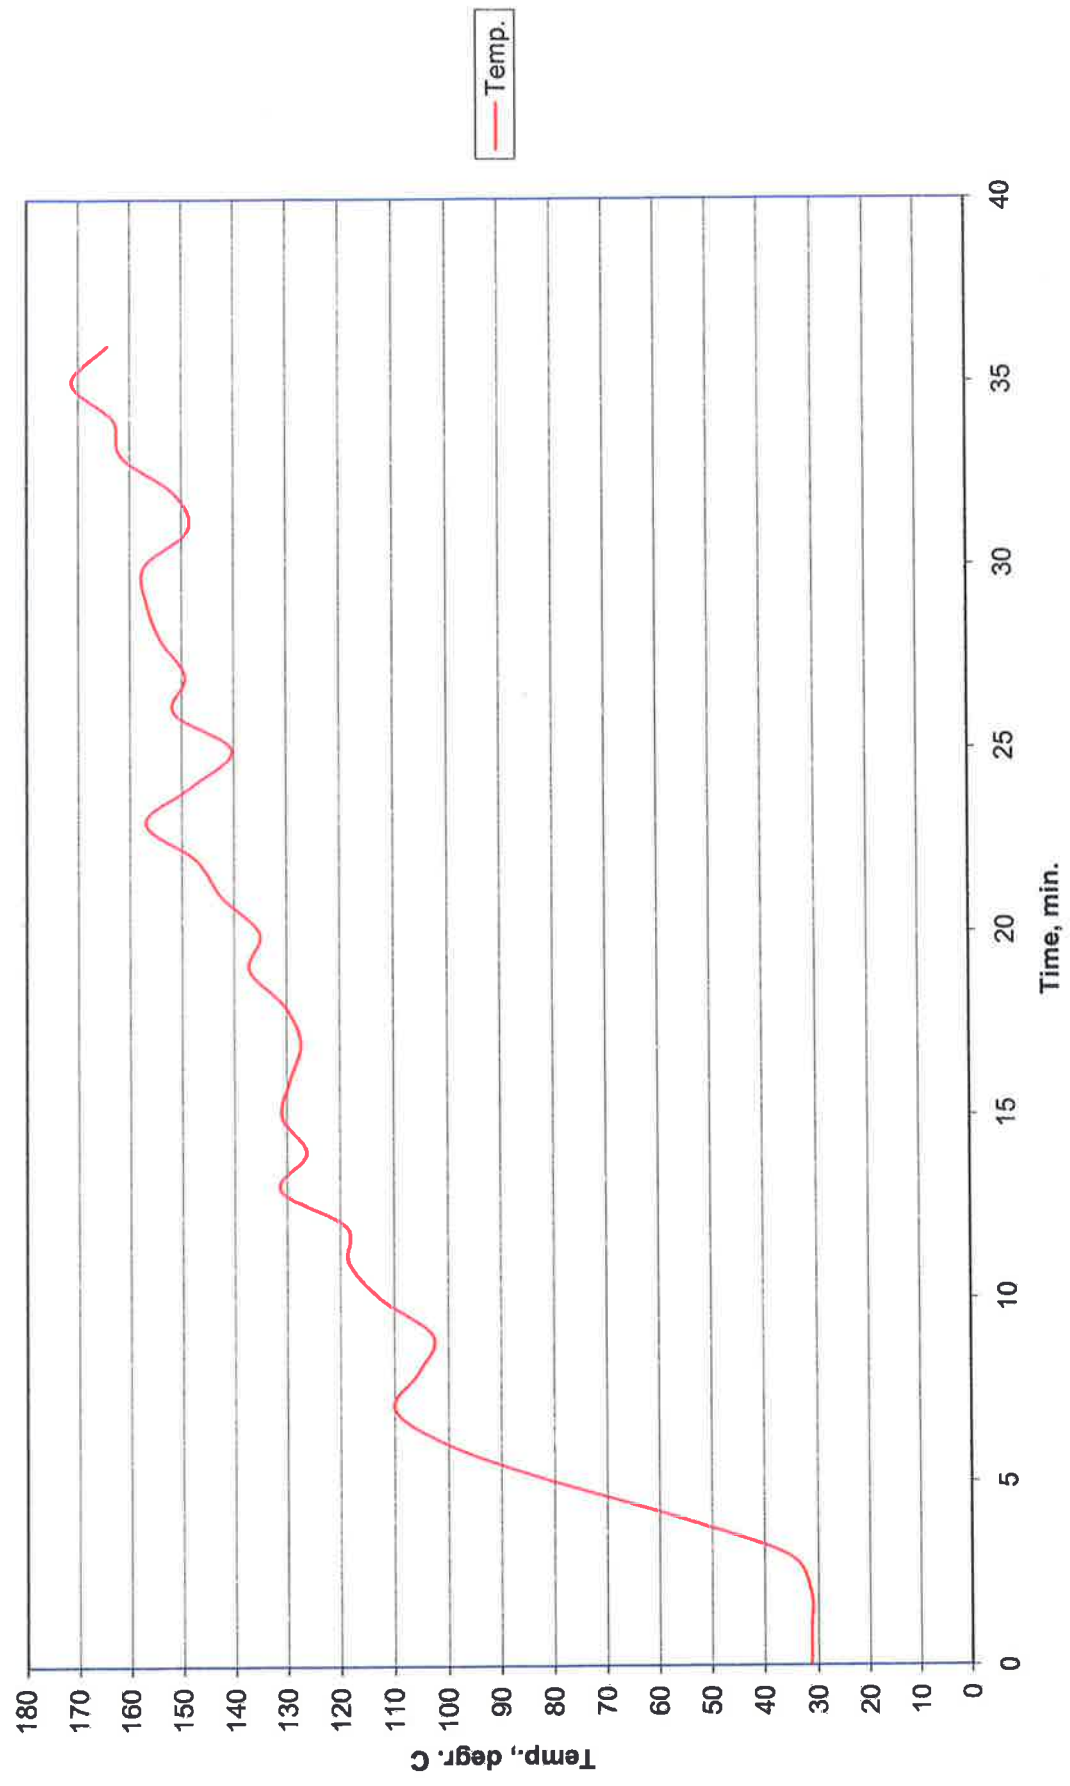
FIGURE 3B

### Temperature Activation Test: Oil Temperature for the Aluminum Hub

The oil temperature data for the test is presented graphically in Appendix B, Figure 3B.
